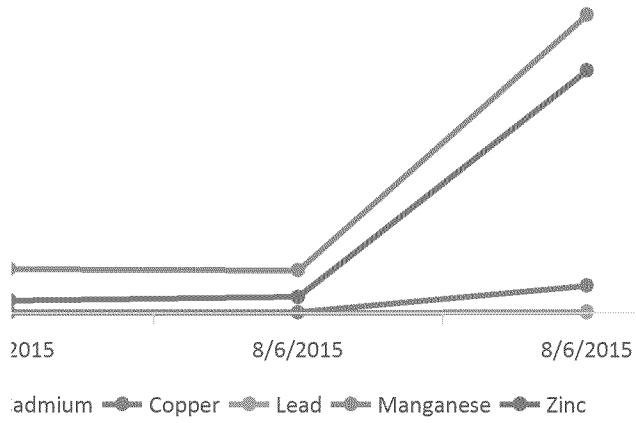
Location: Bakers Bridge

ocation ID	De Sampled	Cadmium	Copper	Lead	Manganes	Zinc
Bakers Bri	8/5/2015	0.353	2.28		306	85.8
Bakers Bri	8/6/2015	0.336	1.88		296	110
Bakers Bri	8/6/2015	5.32	189	1.56	2090	1700
